**West's Road RDF & Waste Management  
Community Reference Group  
AOC  
21st Meeting  
Accepted Notes  
15 December 2016  
Conference Rooms A & B**

**RDF Community Reference Group**  
**Update report on Cell 4A Hotspot – 15 December 2016**

# **Wyndham City Council – Refuse Disposal Facility**

## **Report to EPA – Compliance with Pollution Abatement Notice**

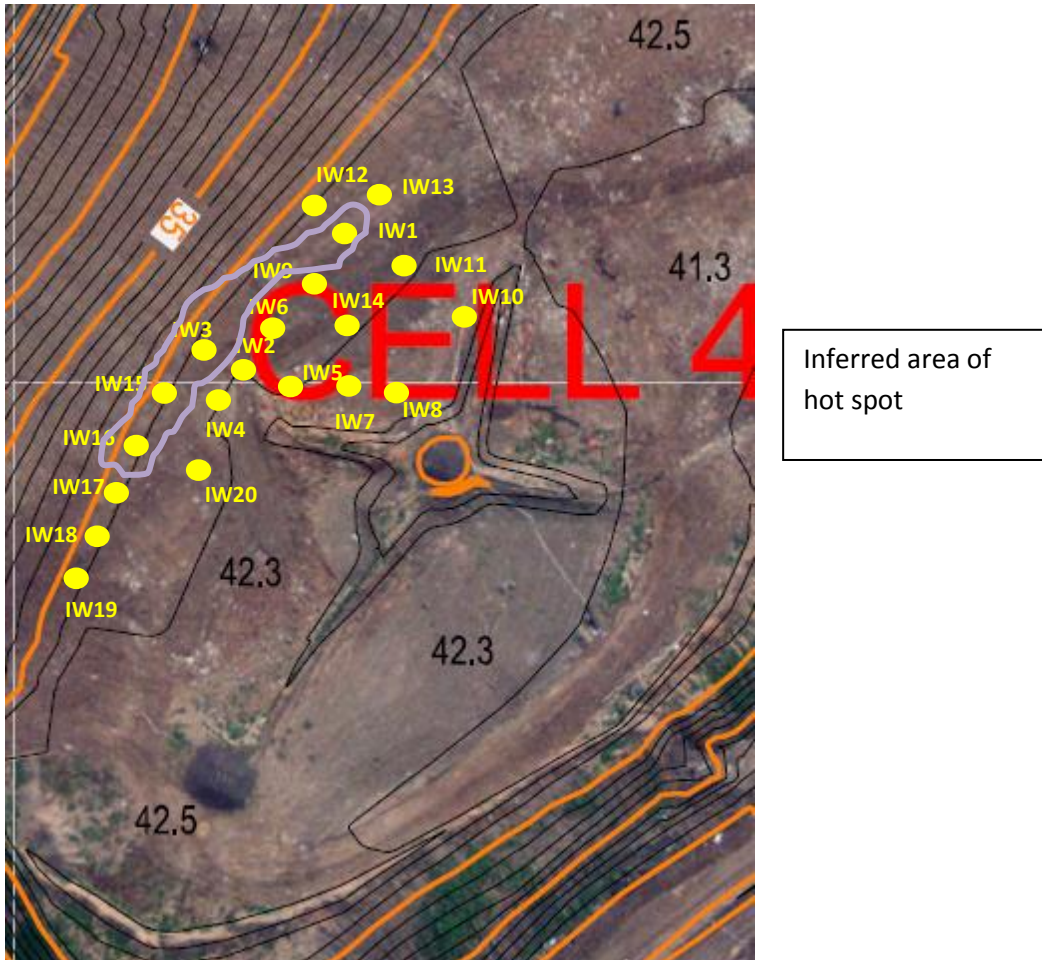
Location of Temperature Probes and Injection Wells

Temperature monitoring of the injection wells has shown temperatures only in the range 45-55°C. This is consistent with the observations made during drilling and inspection of the cores. No elevated temperatures, even in the zone where charring was evident, were noted and no active combustion of any type or form was observed.

Injection of water commenced on Wed 14/12 in wells IW 8, 10, 11 and 13. There were no visible changes at the surface and gas monitoring for methane, carbon monoxide and hydrogen sulphide indicated no emissions at the surface.

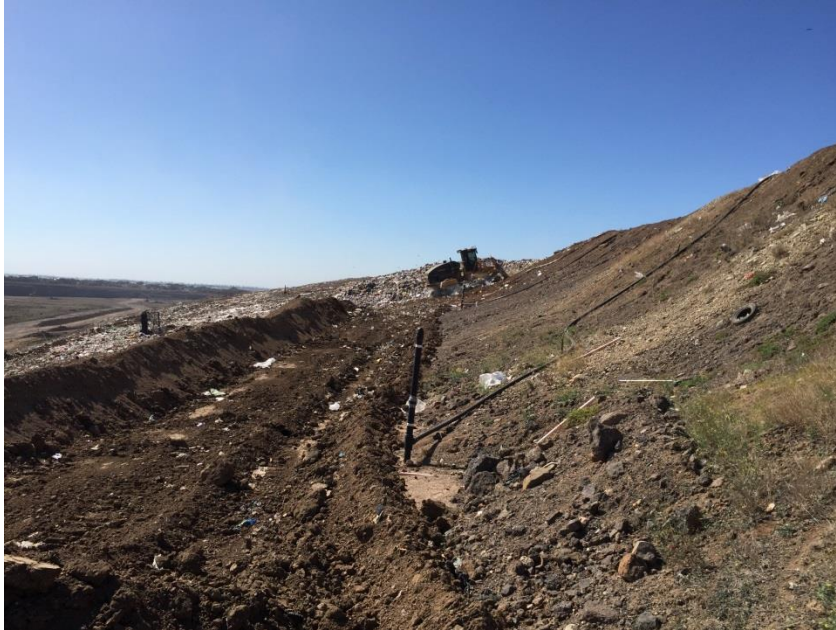
Photograph 1: Commencement of filling the West – upper haul road, April 2016

Reprofiling of Cell 4A has been completed through the placement of waste into the void spaces of the three haul roads that were present on Cell 4A (West – upper, West – lower and East). The filling of all three haul roads has been completed as shown in photographs 1-4.

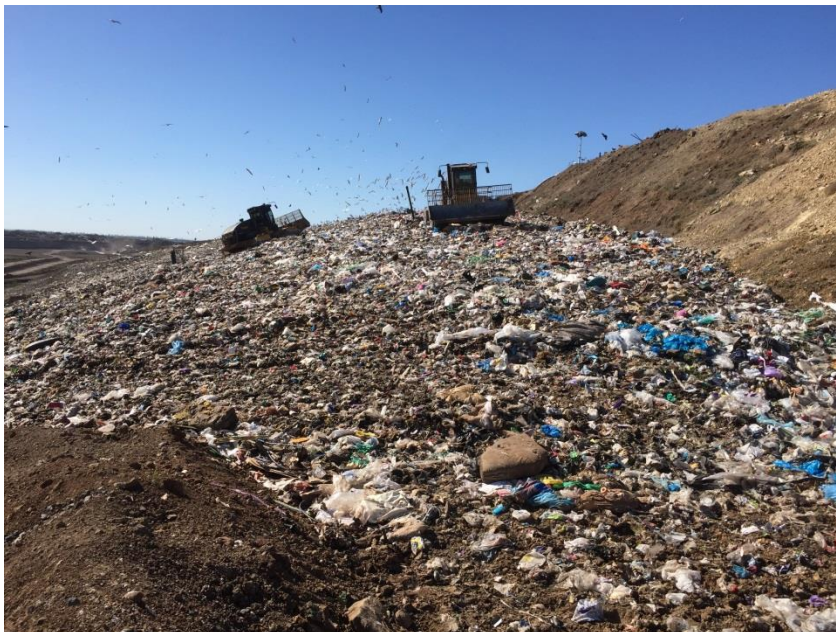
Photograph 2: Further filling the West – upper haul road, May 2016

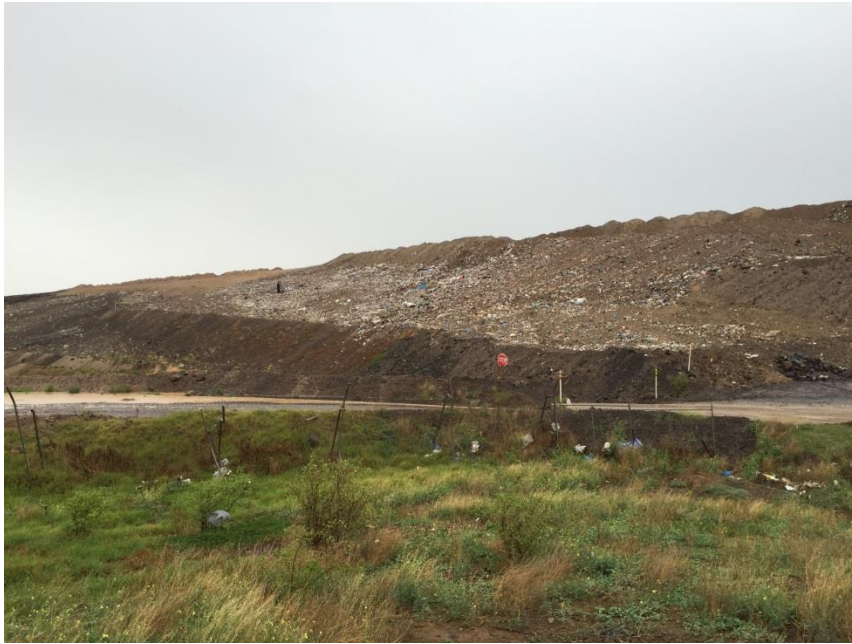
Photograph 3: Filled haul road void space- western batter slope Cell 4A, May 2016

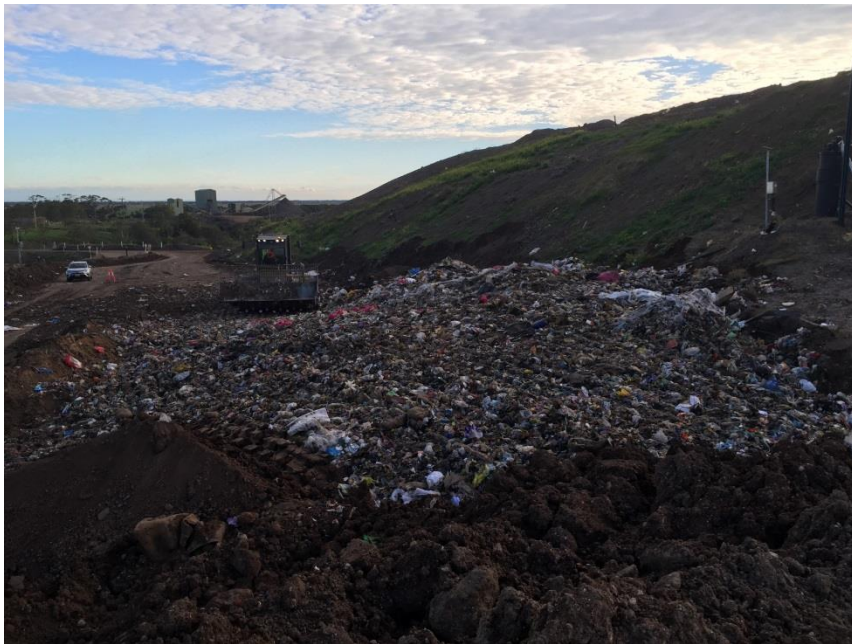
Photograph 4: Filling the East haul road void space- July 2016

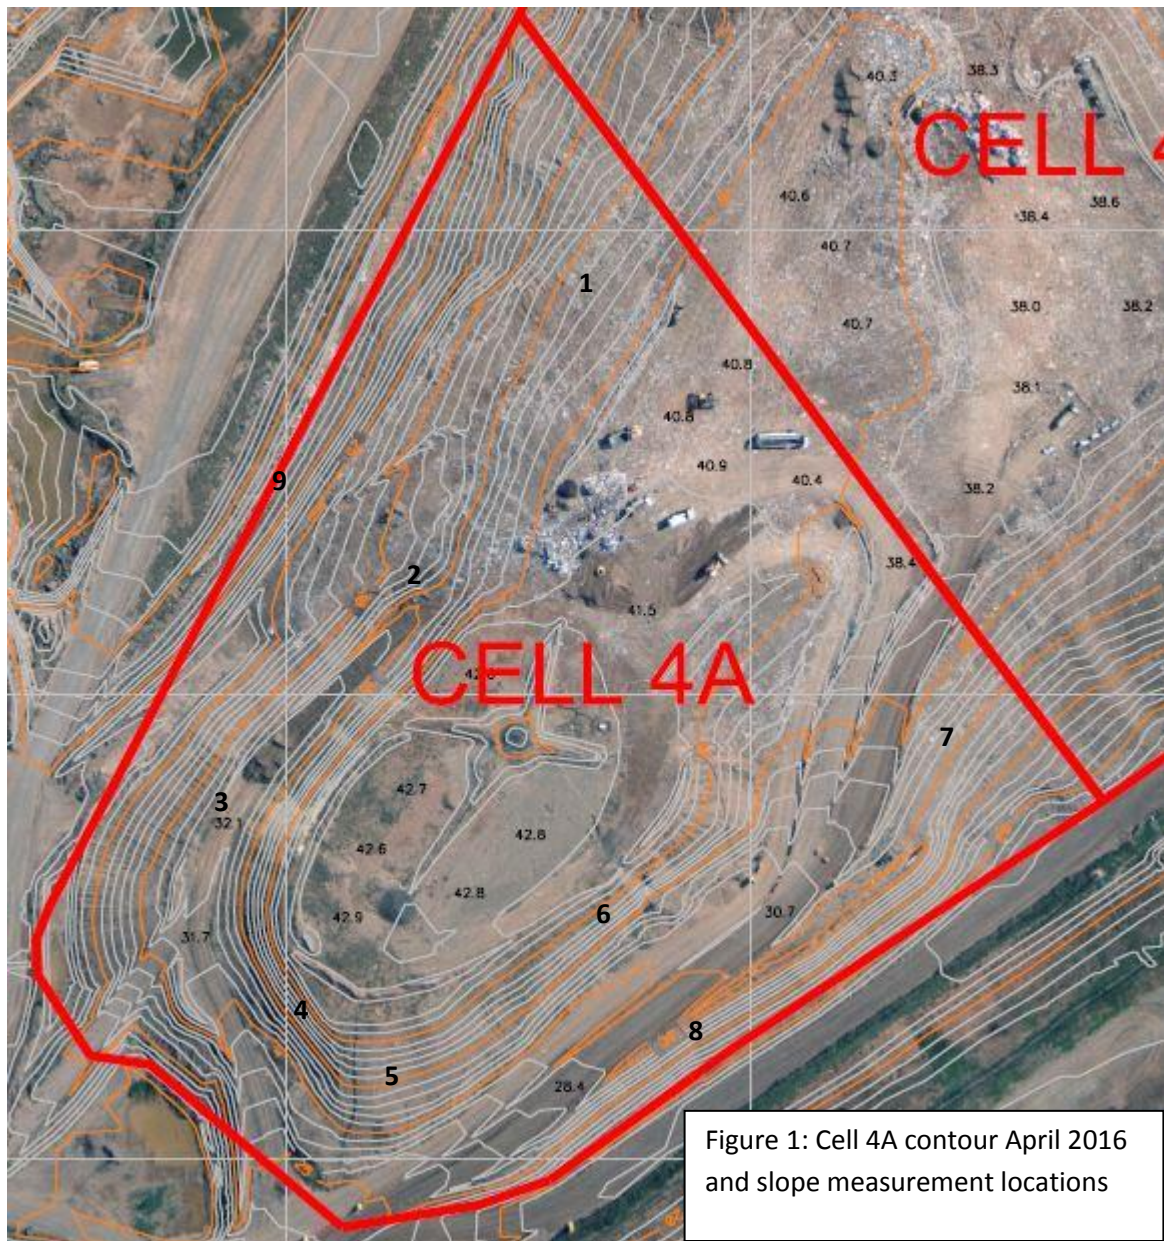
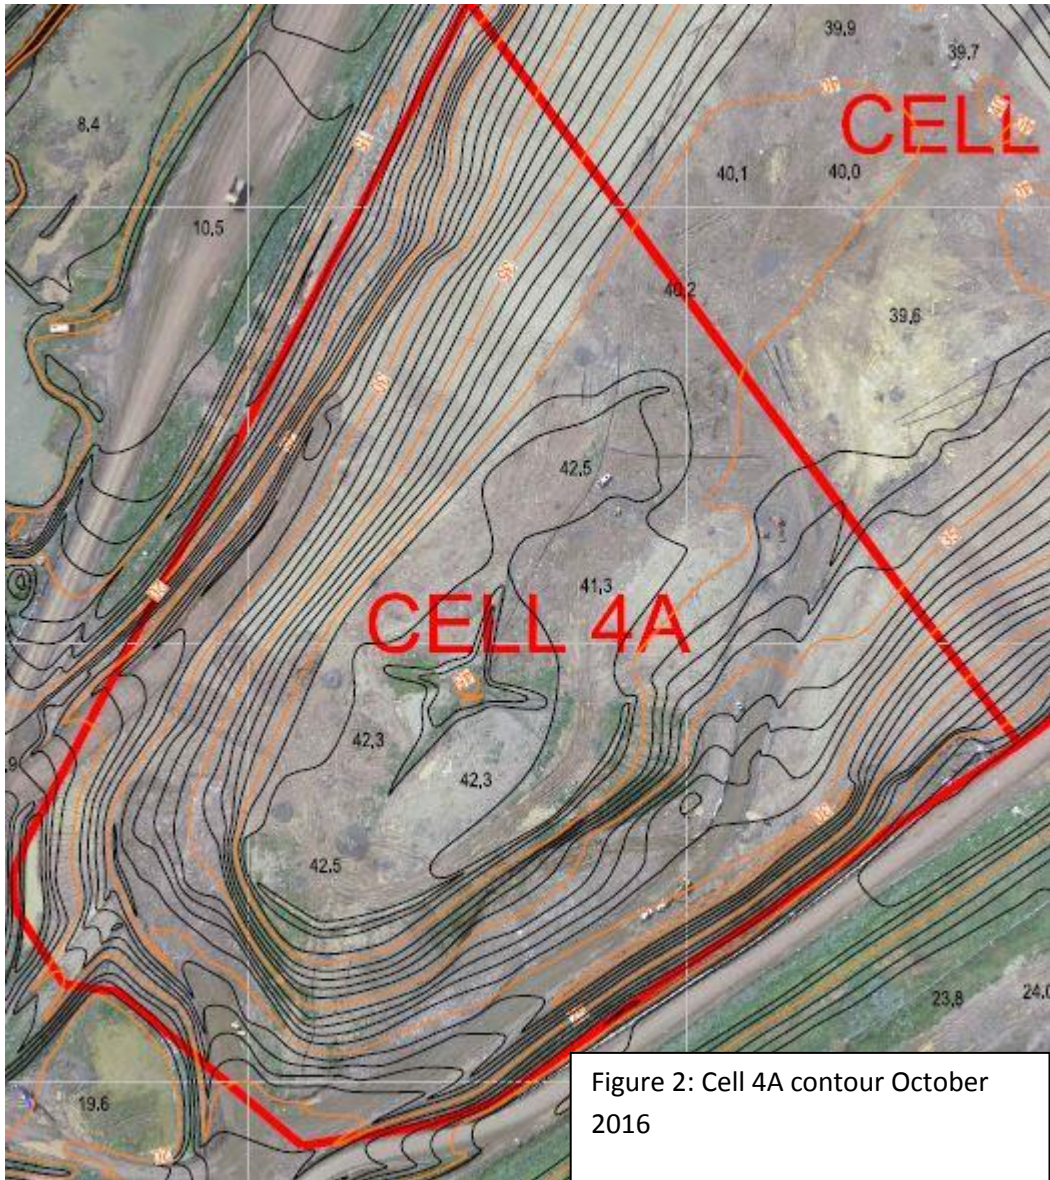
A comparison of the aerial photos from April 2016 and October 2016 shows the change in batter slope on the upper batters of Cell 4A (refer to Figures 1 and 2).

The values shown in the table above indicate that the upper batter slopes are now compliant with the 3:1 H:V requirement except for location 4, which still requires some reprofiling as discussed below.

The lower batters remain steeper than 1:3 due to the constraints of the current haul road (east side), the quarry haul road (west side) and the time taken to complete all the works to date.

1. Measurement to confirm placed intermediate cover is at least 500 mm
2. Extinguish the hot spot on Cell 4A
3. Recommence extraction from the existing gas wells on Cell 4A in a gradual and progressive manner
4. Regular (daily initially) monitoring of gas composition from each individual well upon recommencement of extraction
5. Completion of reprofiling of the southern slope of Cell 4A (Location 4 on Figure 1)

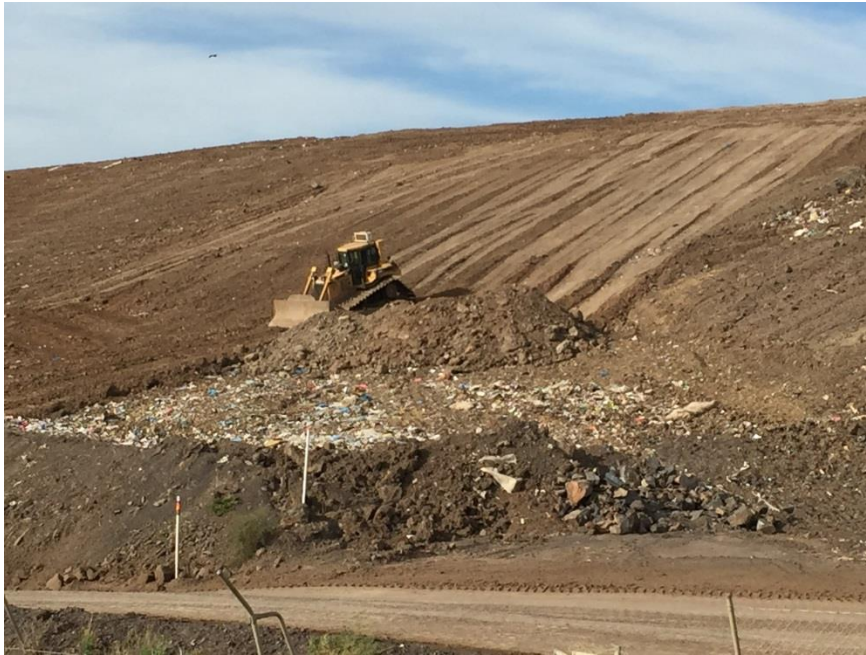
Photograph 5: Placement of intermediate cover, western batters, May 2016

Placement of the intermediate cover is shown in the photographs 5-11.

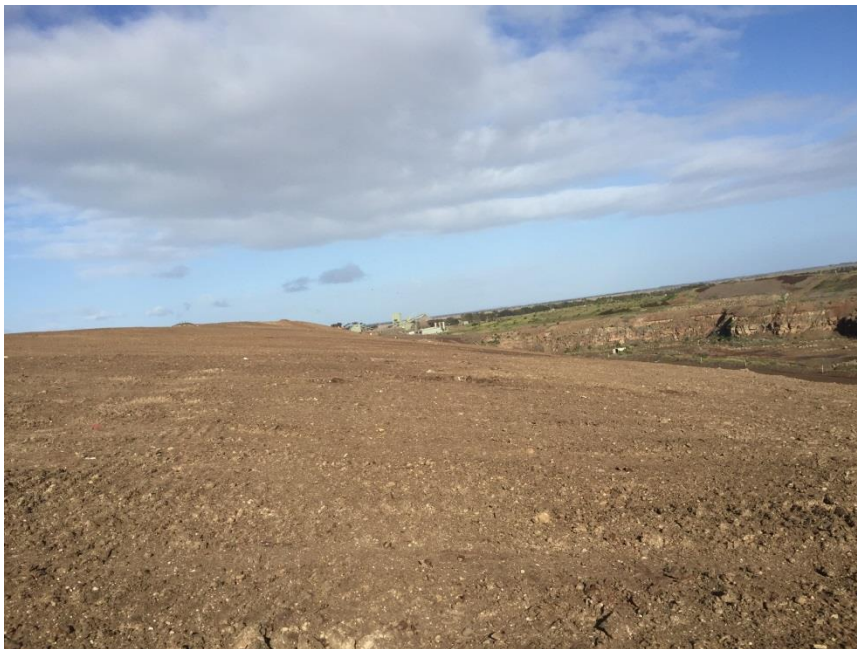
Photograph 6: Completion of intermediate cover, western batters, May 2016

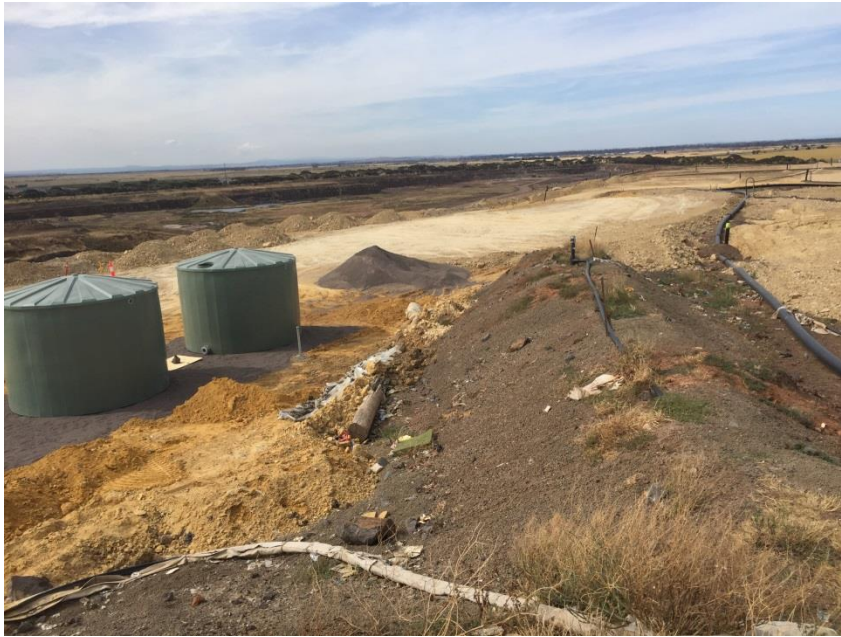
Photograph 7: Completion of intermediate cover, top of Cell 4A, November 2016

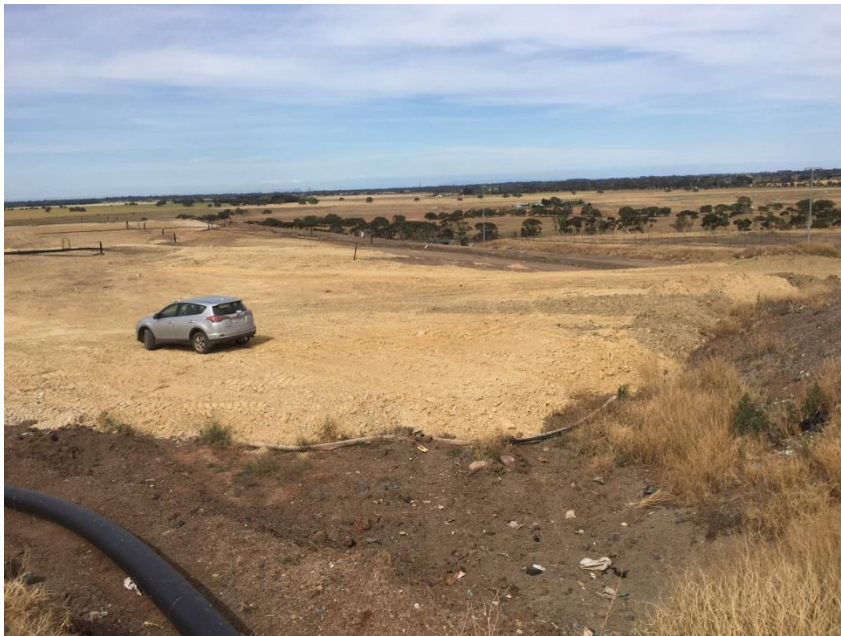
Photograph 8: Completion of intermediate cover, top of Cell 4A, November 2016 (new gas wells on Cell 4B can be seen in the background)

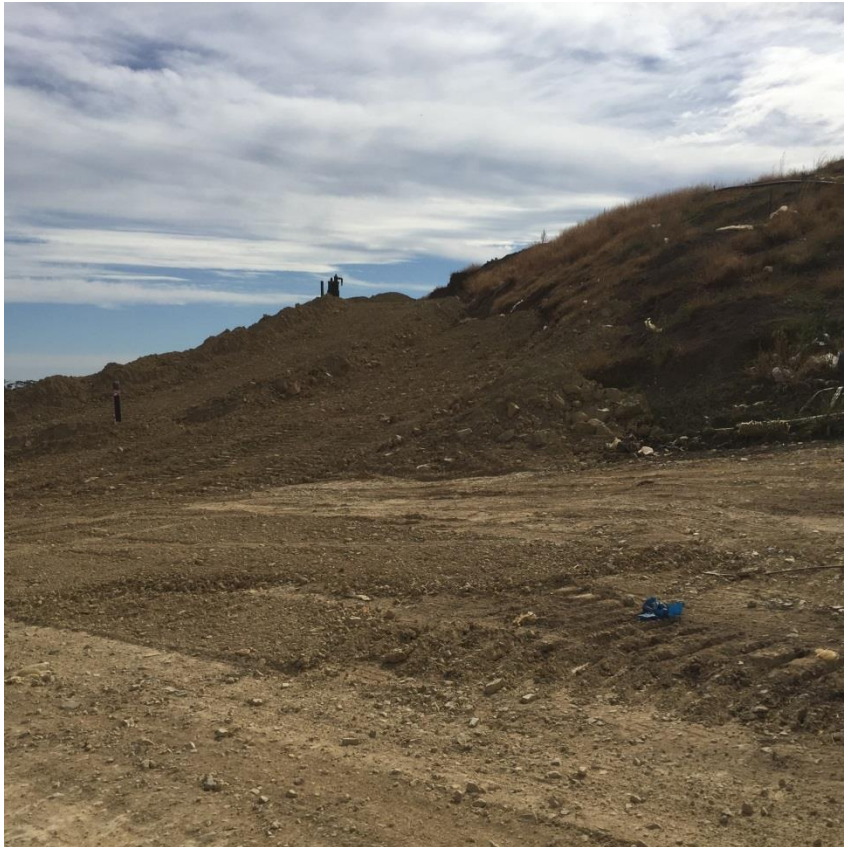
Photograph 9: Placement of intermediate cover around leachate sump on the former Haul Rd - East, November 2016

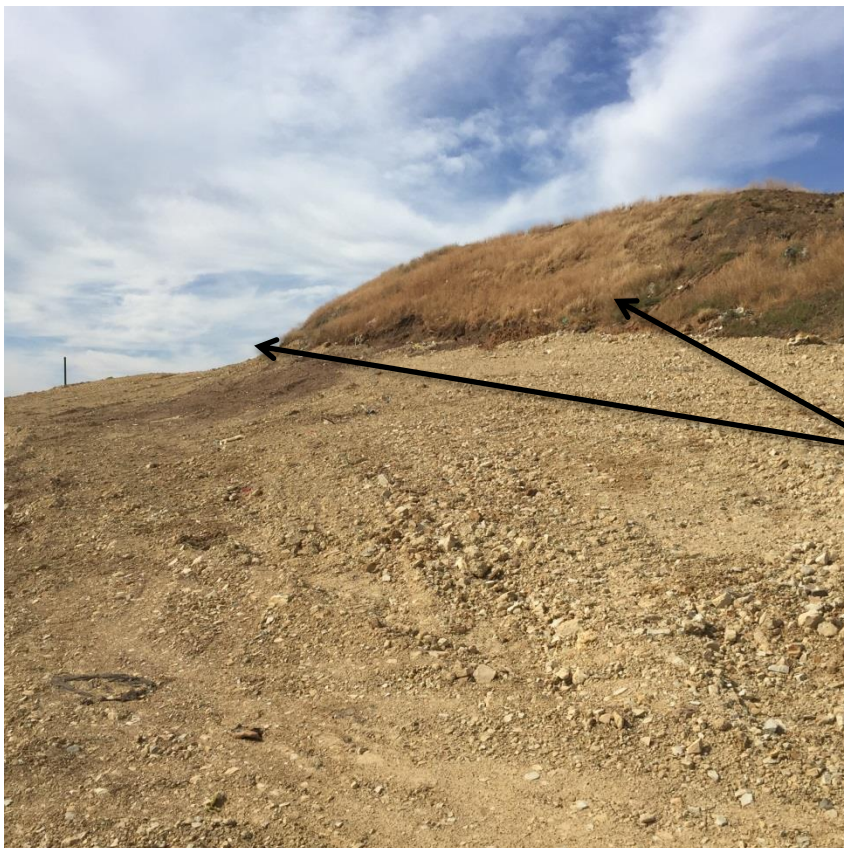
Photograph 10: Placement of intermediate cover around start of the former Haul Rd - West, November 2016 (the areas where additional fill material needs to be placed to achieve 3:1 slope can be clearly seen)

Intermediate cover has been applied to all of Cell 4A except the lower batters. Further work is required to complete the reprofiling around locations 4, 5, and 6 as shown on the April 2016 contour photograph (Figure 1). This will be done in the coming weeks by placement of additional cover and knocking down the bund walls that are currently around the edge of the top of Cell 4A.

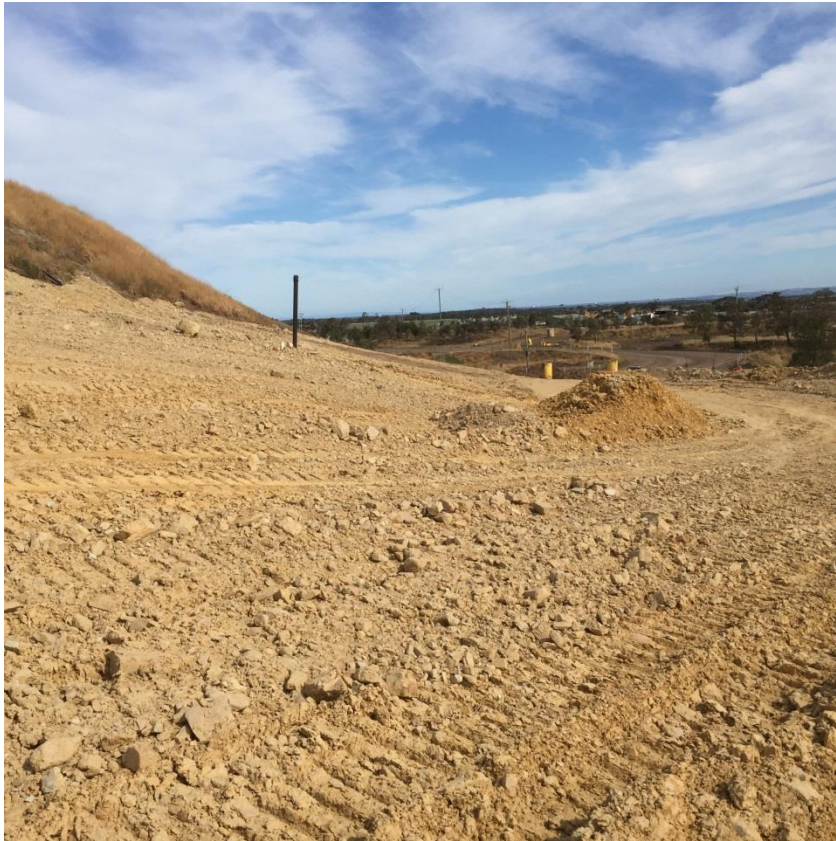
Photograph 11: Placement of intermediate cover around start of the former Haul Rd - West, November 2016

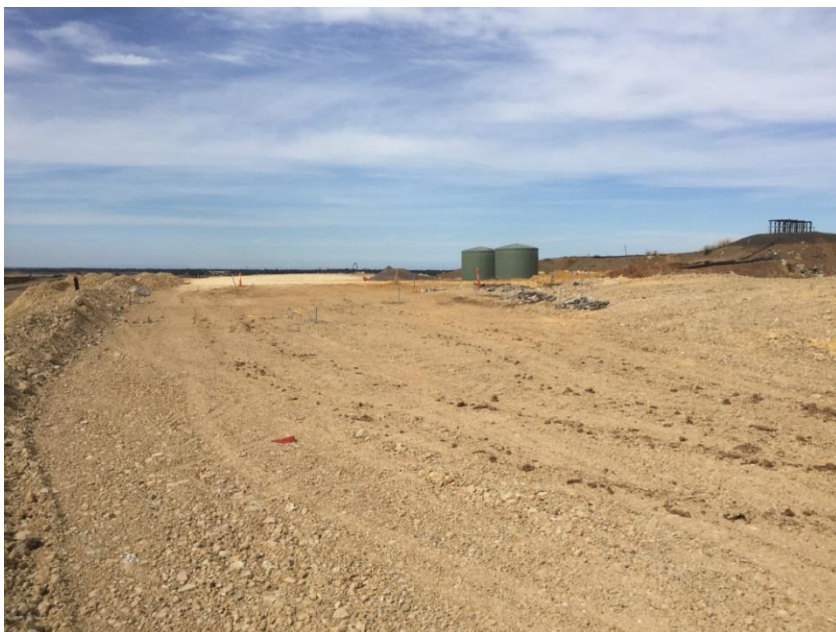
Photograph 12: Injection wells and storage tanks for pumping into the hot spot.

the hot spot using a temperature probe (August 2016) and drilling 10 injection wells to inject leachate into the hot spot zone. Drilling of further injection wells commenced on 1 December 2016 with pumping of liquid to cool the hot spot starting as soon as all the required plumbing works are completed. Photo 12 shows the installation of 2 storage tanks to assist with pumping.
